HRS DOCUMENTATION RECORD COVER SHEET

Name of Site: Jard Company, Inc.

HRS DOCUMENTATION RECORD

Date Prepared: May 2014

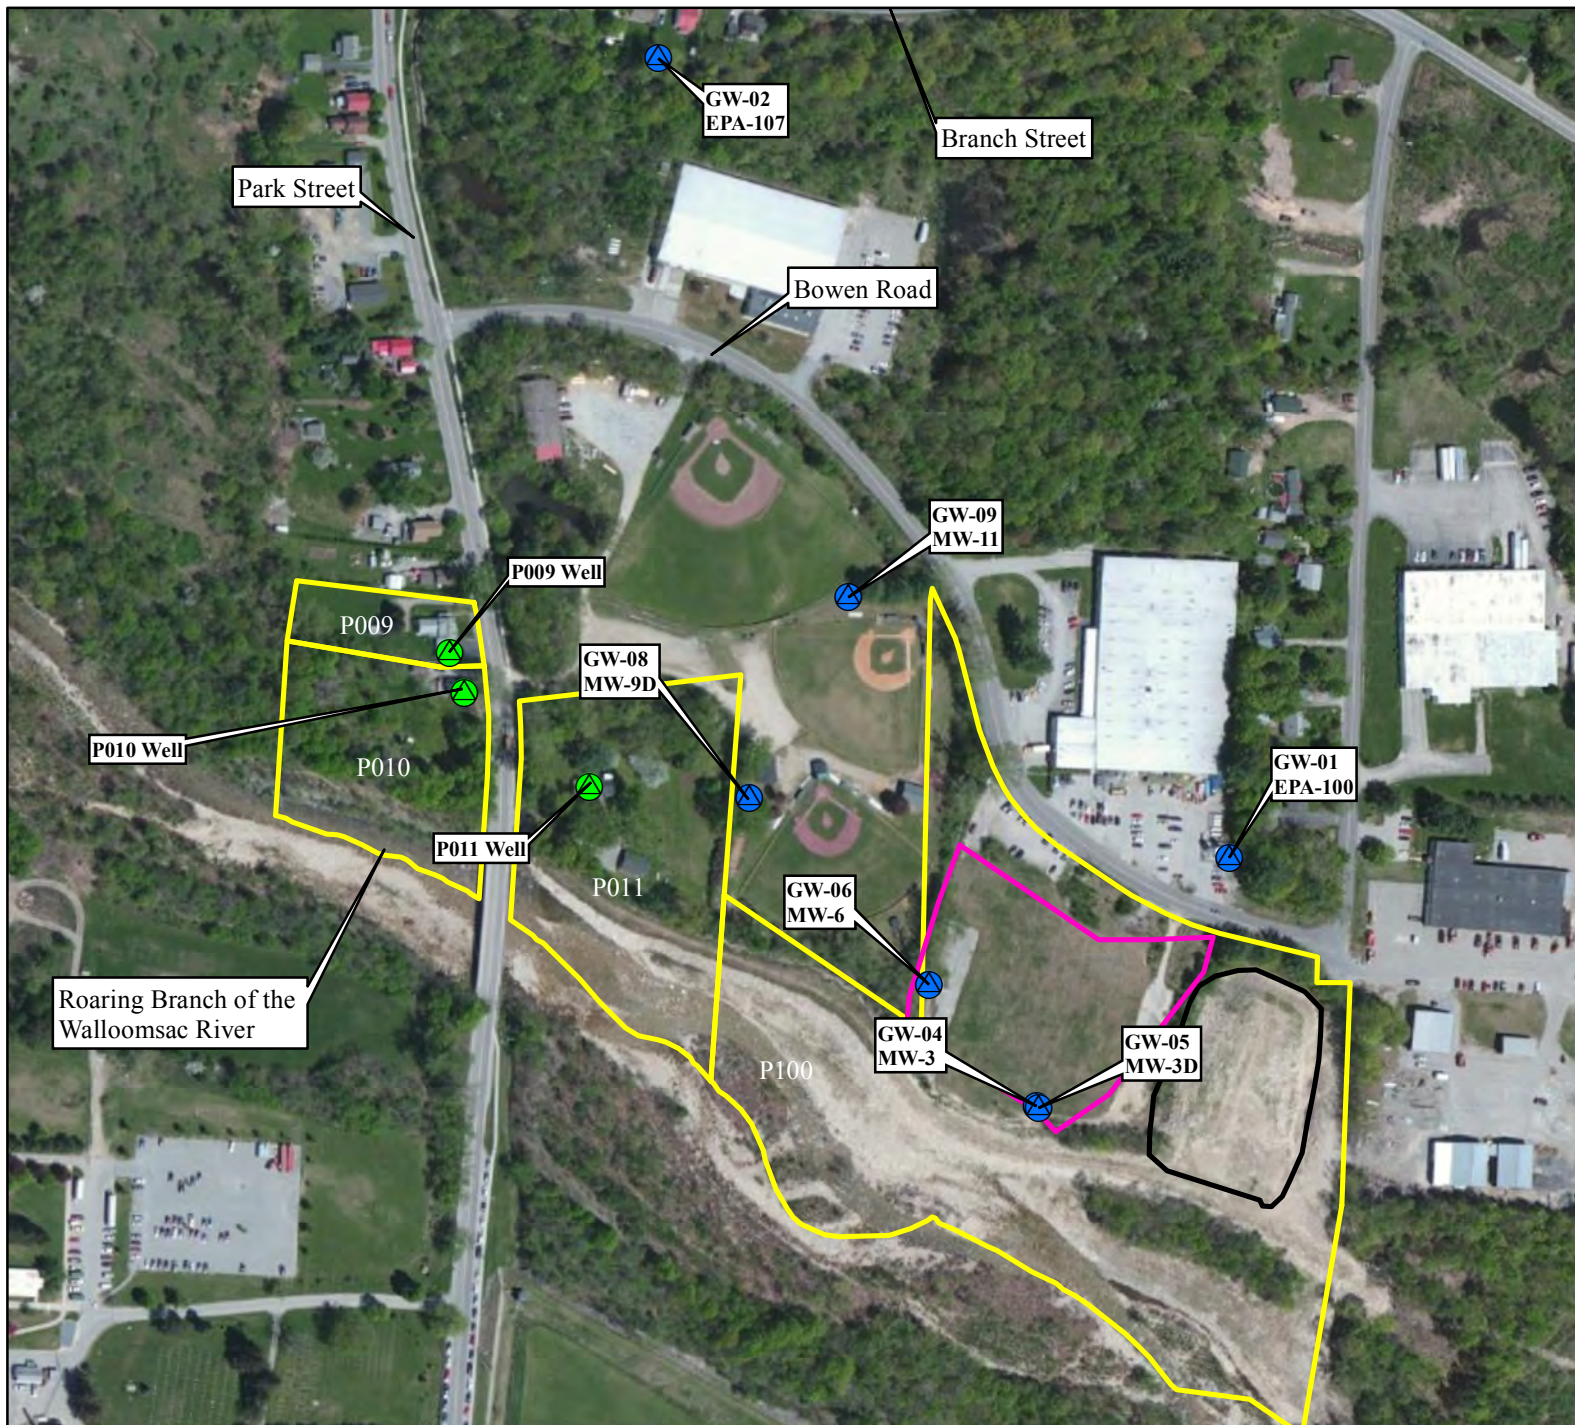
Figure 4
Ground Water and Drinking
Water Sample Location Map

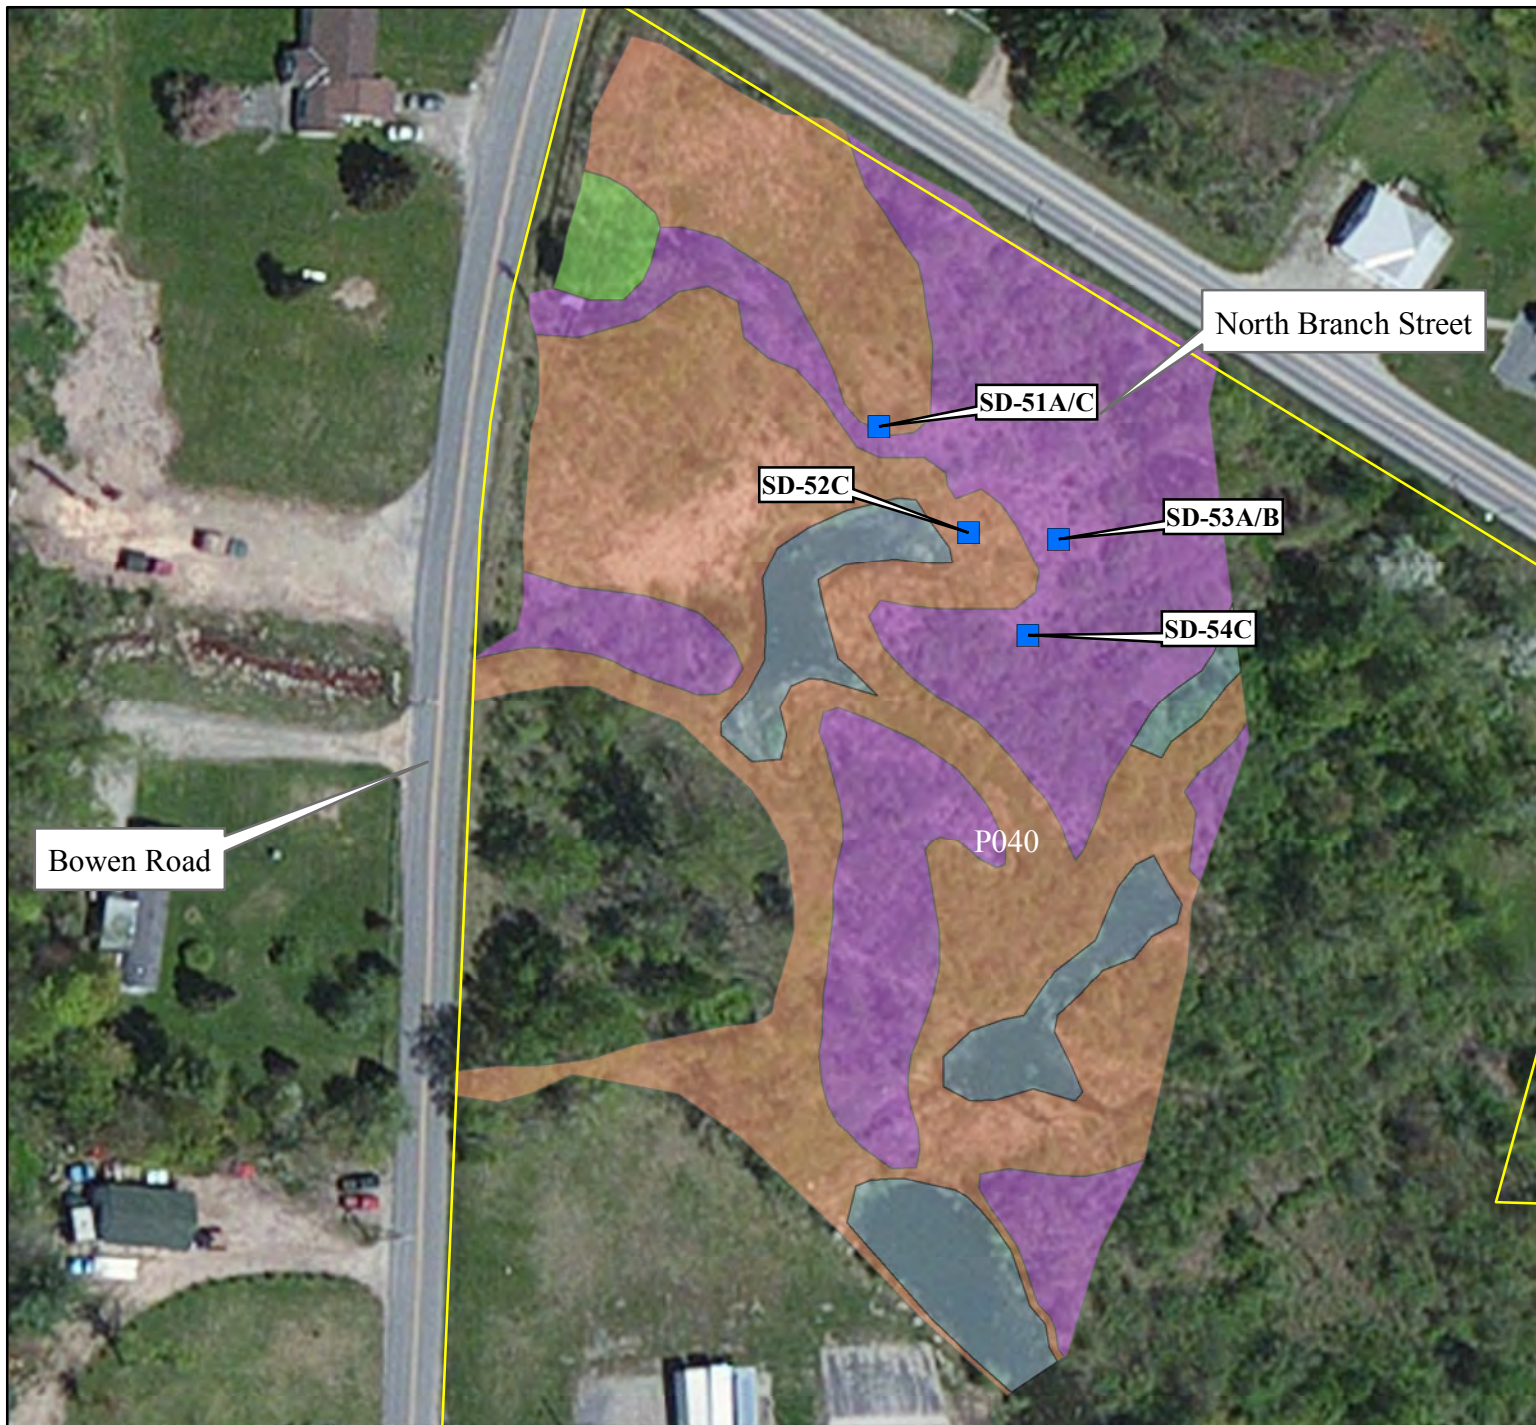
Figure 6A
Background Wetland Sediment
Sample Location Map
Jard Company, Inc.
259 Bowen Road
Bennington, Vermont

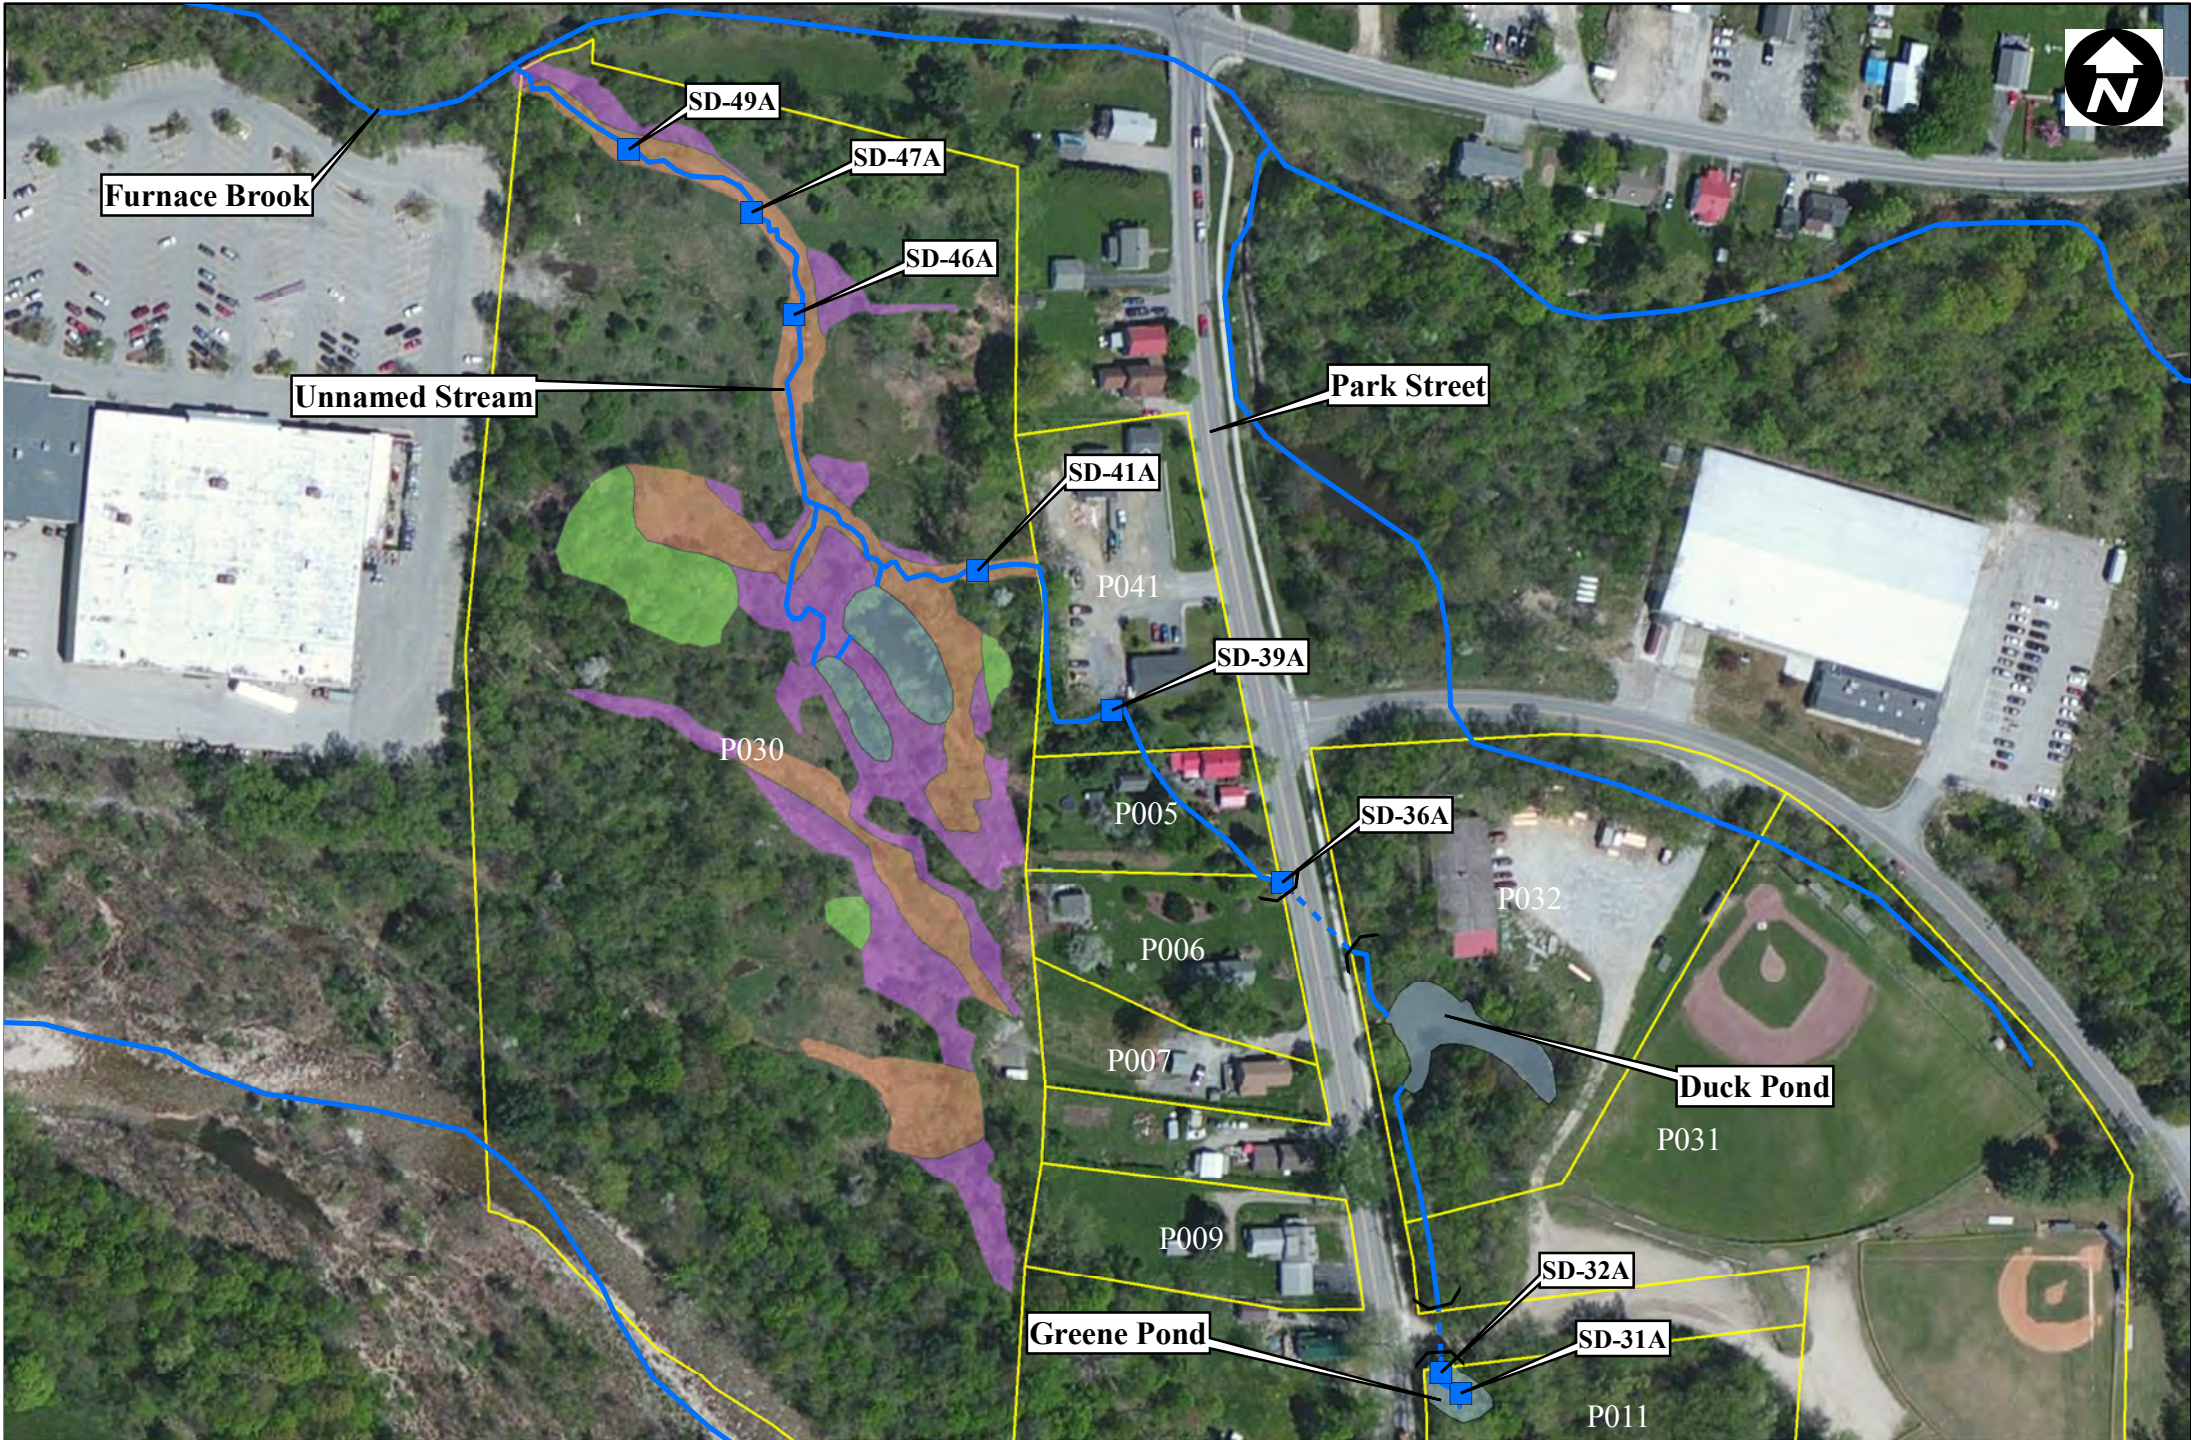
Figure 6B
Contaminated Wetland and
Sediment Sample Location Map
